Liner Wash/Backwash system

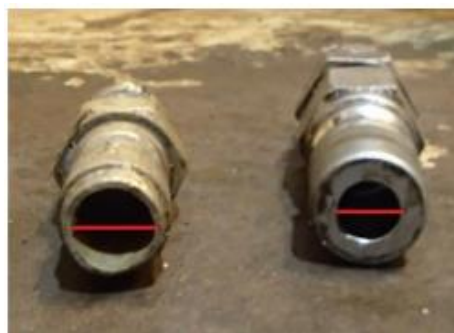
Investigations into the root cause of the reduced flow have revealed that non-OEM replacement parts e.g. smaller diameter hoses, restricted quick disconnect couplings, and rig made make shift spray bars have been introduced to the system that have restricted the flow. Also, worn out liner wash pumps or the pumps by-passed completely and ran via the rig raw water supply have resulted in lack of flow rate to the liners spray nozzles.

The difference between the OEM QRV coupling (left hand) and a non-OEM replacement QRV found in the liner spray system.

The smaller diameter of the throat of the 'replacement' severely reduced the flow rate to the nozzles.
