Manual Lock Failure on BOP

The following safety awareness alert is provided as part of MR Group's efforts to raise the awareness of industry personnel regarding the hazards and risks associated with oil and gas drilling rigs and operations. We thank our Clients and field teams for sharing the information.

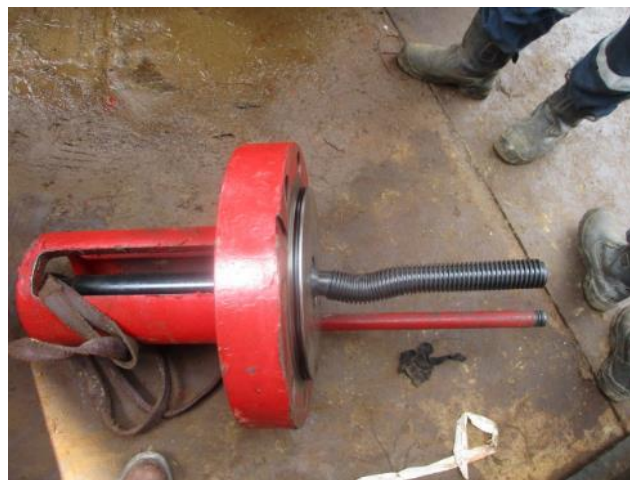
During an annual pressure test conducted on a ram BOP in accordance with API Standard 53, an issue was noted on the manual locks on one of the ram preventers. The ram was not able to fully open after the manual lock was disengaged.

Upon further inspection of the manual locking system, it was noted that the locking shaft was damaged as can be seen in the picture on the left.

The ram BOP was hydraulically opened while the locking shaft had not been fully disengaged. The high degree of force

generated when opening the ram BOP provided by the BOP hydraulic control system caused the locking shaft to bend. This resulted in the ram BOP on the bonnet being unable to fully open.

Pressure testing should be carried out in accordance with with API Standard 53, 5th edition 2023. After the initial pressure testing is completed, the manual locks are to be fully disengaged to ensure no damage occurs to the manual locking system.
