Raising Wire Failure

The following safety awareness alert has been provided by one of ModuResources' clients. ModuResources would like to thank the client for sharing the information.

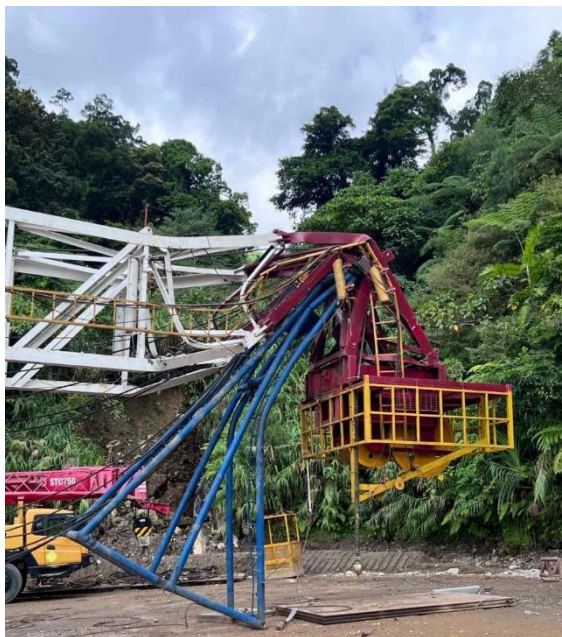
The rig was in the process of raising the mast when the wire rope parted close to the area where the wire rope passes through the becket. This resulted in the mast falling onto the A-frame causing damage to the mast in the picture below.

Left: Result of the raising wire failure.

- Several years ago the mast had been replaced, and the newly fitted mast was fitted with different size raising sheaves than the old mast. A sheave with a larger sheave profile could allow the wire rope to collapse under load, causing additional wear on the wire rope.
- The raising wire in use at the time of the accident was of inferior quality.
- The raising wire was not connected to a raising adaptor, but instead run through the becket.
- Measurements of the raising sheaves were not part of the maintenance system checks.
- Minimum quality requirements for the raising wire were not checked prior to purchasing.

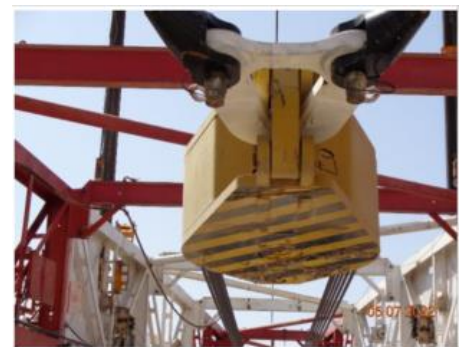
Below: Normal set with the use of a raising line adaptor.
