Temporary Equipment as a Potential Source of Ignition

The following safety awareness alert has been provided by one of MR Horizon Resources International's Client. MR Horizon Resources International would like to thank the Client for sharing the information.

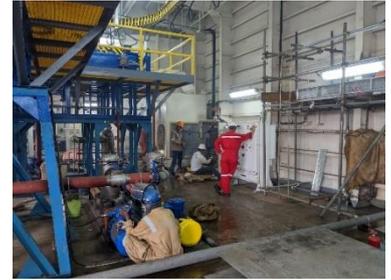
MR Group were conducting an inspection during the reactivation of a tender drilling rig prior to an upcoming drilling campaign. It was noted that solids control equipment had been installed in the heavy tool store area of the tender. The nature of operation of the solids control equipment, by definition, created a hazardous area.

The classification society was consulted and a plan implemented, making the solids control room a temporary hazardous area suitable for the intended operations. The plan included a

review of lighting, PA/GA speakers and ventilation arrangements. A review of the control panels identified inconsistencies due to equipment modification and incomplete certification. Updating of the rig's hazardous area drawing and hazardous area equipment register was also required.
